## REDCAR STATION SIGNAL SIGHTING PROJECT FOR PROPOSED SCAFFOLD ARRANGEMENT

**Client: North South Rail**

Redcar Station VR Proposed Scaffolding

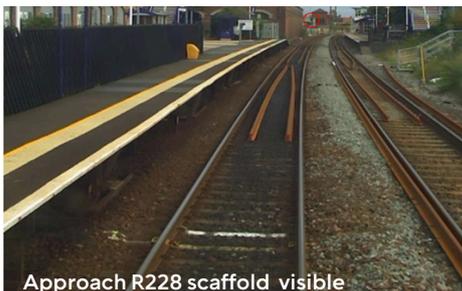
Approach R228 scaffold visible

- R224 – No lineside signage was identified as being affected by the temporary scaffold.
- The approach to R228 was found to be compliant to the distance documented on R228 SSF. In addition, the AvRD of R228 was found to be 270m unobscured with Platform 1 occupied, and 370m unobscured if Platform 1 is not occupied.
- That the proposed temporary scaffold would not obscure the readability of R228 & R224. However, works taking place on the building may act as a distraction to train drivers. It was therefore recommended that Network Rail & Train Operating companies issue notification of the works to train drivers to mitigate any risk.
- It was also recommended that Network Rail should assess the possibility of sunlight reflection from the scaffold and any possible impact of this on train drivers in both the Up and Down directions.
